**Flood Control Project Maintenance
Levee Inspections**
LMA District Cover Sheet
Spring 2019 Levee Inspection Results

Reclamation District No. 0150 Merrit Island

Spring 2019 Levee Inspection Results

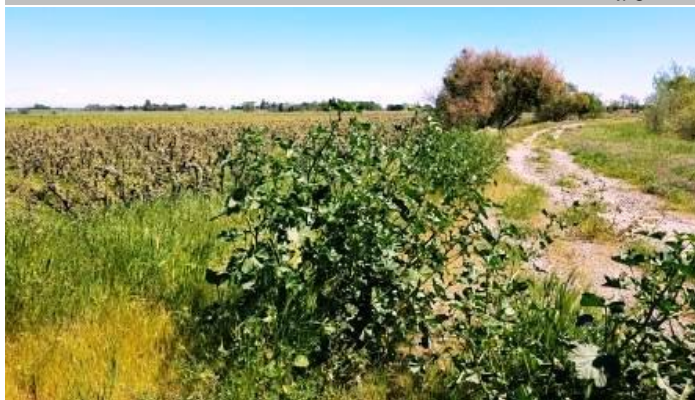
Photo 1 of 1 : SP_2019_RD0150_15_1_20190415_00001.jpg

LM Start	0.01	Rating **	M	Issue No.	1
LM End	0.07	Issue Type +	Ma	Location *	LS
Category	Earthen Levee			GPS Latitude/Longitude	
				Start	End
Item	Vegetation			38.332510 °	38.332318 °
				-121.583302 °	-121.582227 °
DWR ID	DWR_RD0150_01_s_2019_1				
Comment Code					
V2 : Remove the wild growth other than native grasses from the levee slopes.					
Inspector Comment

View of tall landside vegetation. Spring 2019

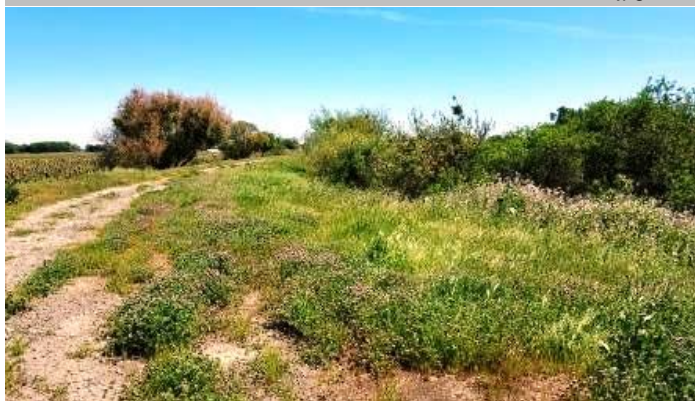
Photo 1 of 1 : SP_2019_RD0150_15_2_20190415_00002.jpg

LM Start	0.01	Rating **	M	Issue No.	2
LM End	0.07	Issue Type +	Ma	Location *	WS
Category	Earthen Levee			GPS Latitude/Longitude	
				Start	End
Item	Vegetation			38.332510 °	38.332313 °
				-121.583302 °	-121.582208 °
DWR ID	DWR_RD0150_01_s_2019_2				
Comment Code					
V1 : Control annual grass and weeds on the levee slopes and easements.					
Inspector Comment

View of tall waterside vegetation. Spring 2019

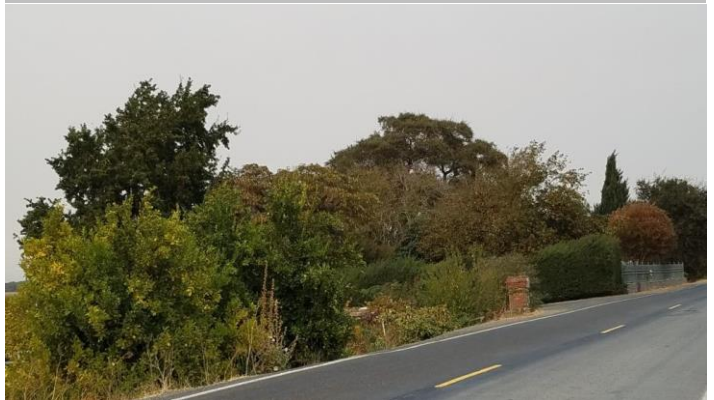
Photo 1 of 1 : SP_2019_RD0150_16_106_20190307_00062.jpg

LM Start	0.14	Rating **	U	Issue No.	106
LM End	0.16	Issue Type +	En	Location *	LS
Category	Earthen Levee			GPS Latitude/Longitude	
				Start	End
Item	Vegetation			38.329782 °	38.330058 °
				-121.574820 °	-121.574574 °
DWR ID	DWR_RD0150_02_s_2018_106				
Comment Code					
V6 : Landscaping					
Inspector Comment					
Landowner needs to maintain vegetation and remove unpermitted fruit trees on levee slope.

View of landscaping that needs to be maintained and of unpermitted citrus trees on levee slope. Fall 2018

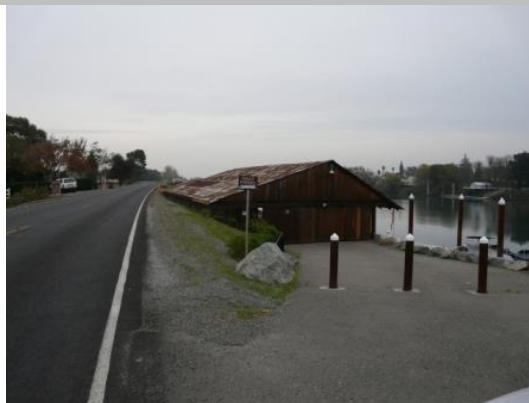
Photo 1 of 1 : SP_2019_RD0150_16_49_20190307_00026.jpg

LM Start	0.16	Rating **	U	Issue No.	49
LM End	0.16	Issue Type +	En	Location *	WS
Category	Earthen Levee			GPS Latitude/Longitude	
				Start	End
Item	Encroachments			38.330047 °	38.330047 °
				-121.574538 °	-121.574538 °
DWR ID	DWR_RD0150_02_s_2012_49				
Comment Code					
BU : Building					
Inspector Comment

Building located on waterside of levee.

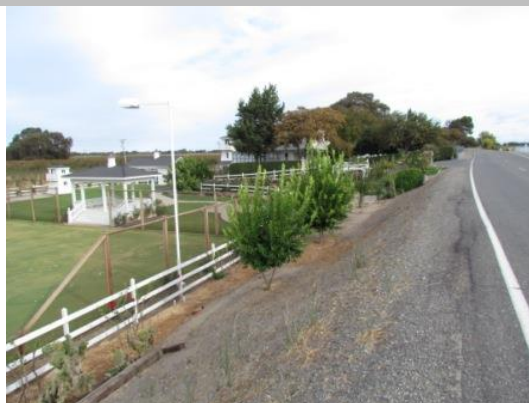
Photo 1 of 1 : SP_2019_RD0150_16_990_20190307_00073.jpg

LM Start	0.17	Rating **	M	Issue No.	990
LM End	0.21	Issue Type +	En	Location *	LS
Category	Earthen Levee			GPS Latitude/Longitude	
				Start	End
Item	Vegetation			38.330173 °	38.330576 °
				-121.574490 °	-121.574093 °
DWR ID	DWR_RD0150_02_s_2012_990				
Comment Code					
V6 : Landscaping					
Inspector Comment

Landscaping was found on the landside of the levee looking upstream.

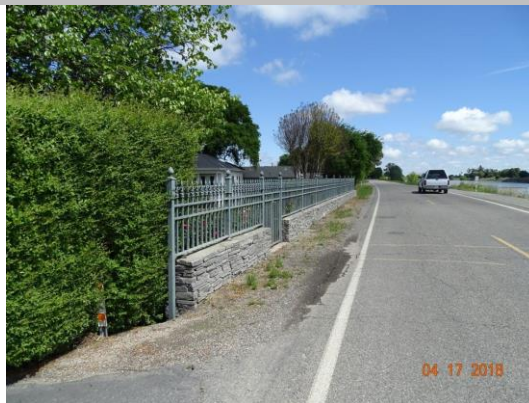
Photo 1 of 1 : SP_2019_RD0150_16_105_20190307_00061.jpg

LM Start	0.18	Rating **	U	Issue No.	105
LM End	0.20	Issue Type +	En	Location *	LS
Category	Earthen Levee			GPS Latitude/Longitude	
				Start	End
Item	Encroachments			38.330339 °	38.330500 °
				-121.574311 °	-121.574138 °
DWR ID	DWR_RD0150_02_s_2018_105				
Comment Code					
FE : Fence					
Inspector Comment					
Landowner has installed a fence that is blocking access to levee.

Iron fence was not included under Permit 17359-A; only retaining wall, terraced slope, and steps were approved on landside. Spring 2018

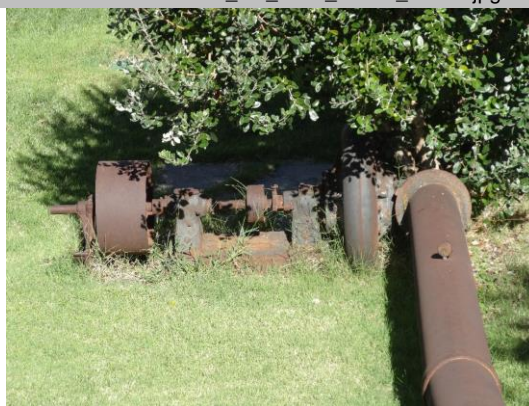
Photo 2 of 3 : UCIP_SP_2019_42700_34246.jpg

LS view: abandoned pipe and pump on landside toe.

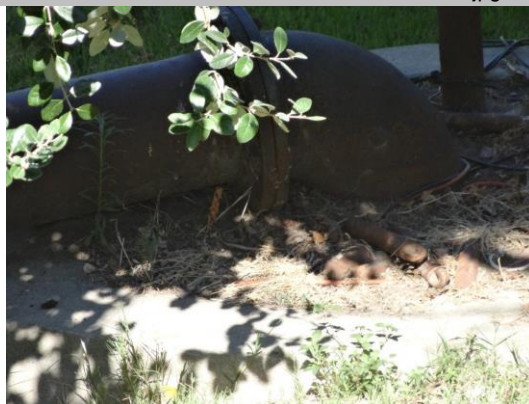
Photo 3 of 3 : UCIP_SP_2019_42700_34245.jpg

LS view: abandoned pipe and concrete box on landside toe.

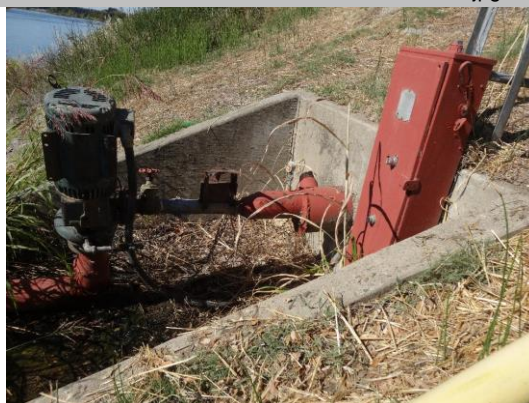
Photo 2 of 3 : UCIP_SP_2019_20268_34243.jpg

UCIP Comments: - Water leaks from pressure breaker.- Distribution box at the landward toe not found/visible.- Service pole on LS toe.

WS view: pump, electric control box, electric conduit on concrete pad.
Water leaks from pressure breaker.

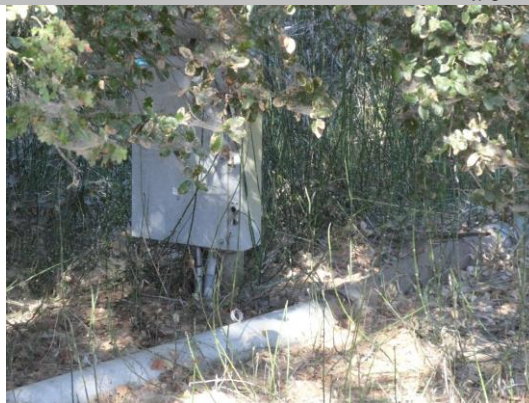
Photo 2 of 2 : UCIP_SP_2019_20284_34264.jpg

Comment Code						
Inspector Comment						
FS_ID:20284 DS_ID:22419 EP_NO: N/A Repair Type: Non-Urgent Crossing Status: Found UCIP Comments: Needs proper abandonment. FIELD_STRUCT_DESC: 8-inch steel irrigation discharge pipe through the levee, invert elevation 5.7 feet below the crown. Power line on the landside (LS). (Retention of an irrigation pumping plant, a centrifugal pump, and an 8-inch steel pipe through the levee with a gate valve at the waterside [WS] end authorized under Permit No. 9446, 1974 - Hanna Olsen). [Additional Reference(s): DWR Levee Log, 2005. USACE Sacramento O&M Manual 112, March 1957, (RM 34.49)]. FS Date: 8/27/2013

LS view: exposed steel pipe and power pole on levee toe.

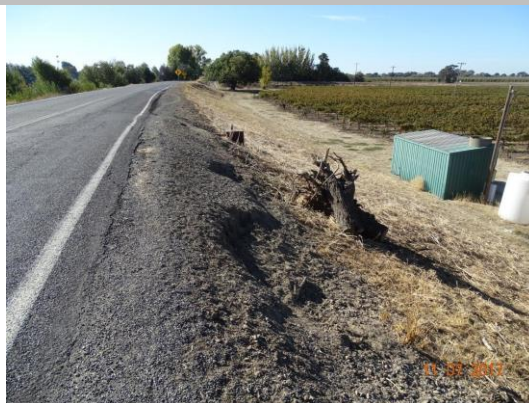
Photo 1 of 2 : SP_2019_RD0150_16_59_20190307_00041.jpg

LM Start	0.71	Rating **	U	Issue No.	59 (cont)
LM End	0.71	Issue Type +	Ma	Location *	LS

View of the tree trunk on the landside of the levee. Fall 2017

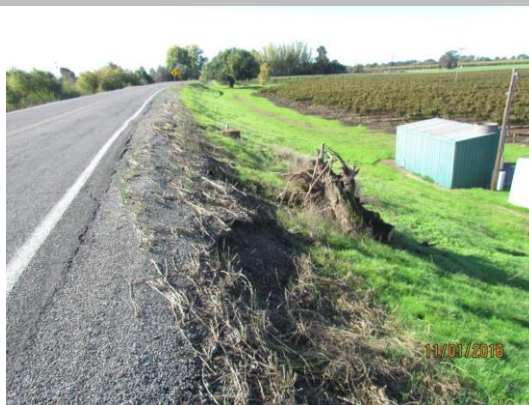
Photo 2 of 2 : SP_2019_RD0150_16_59_20190307_00042.jpg

View of the tree limbs and roots on the landside of the levee looking downstream. Fall 2016

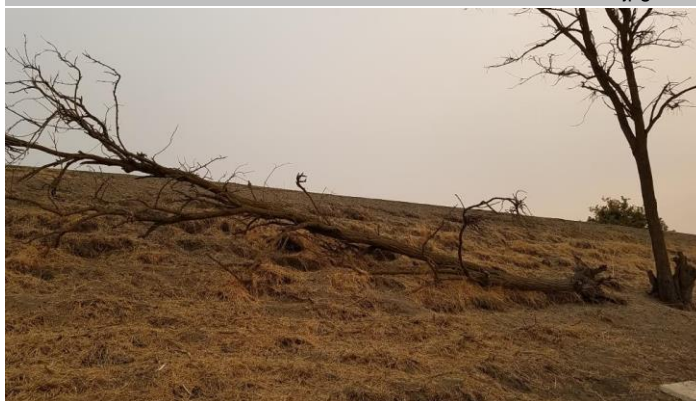
Photo 1 of 1 : SP_2019_RD0150_16_73_20190307_00048.jpg

LM Start	0.79	Rating **	M	Issue No.	73
LM End	0.79	Issue Type +	Ma	Location *	LS
Category	Earthen Levee			GPS Latitude/Longitude	
				Start	End
Item	Encroachments			38.337307 °	38.337307 °
				-121.567698 °	-121.567698 °
DWR ID	DWR_RD0150_02_f_2017_73				
Comment Code					
TR : Tree or limb					
Inspector Comment					
The dead tree needs to be removed from the levee slope.

View of fallen tree on landside levee slope. Fall 2018

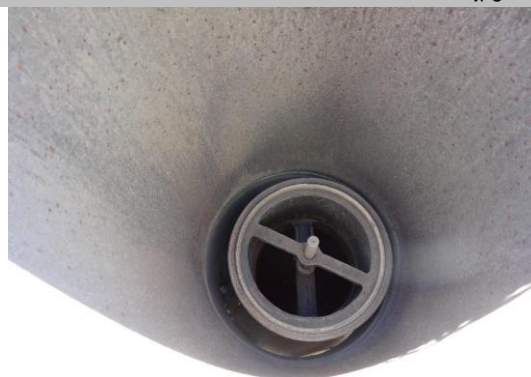
Photo 2 of 3 : UCIP_SP_2019_20727_34888.jpg

WS view: siphon breaker in pipe riser on levee shoulder.

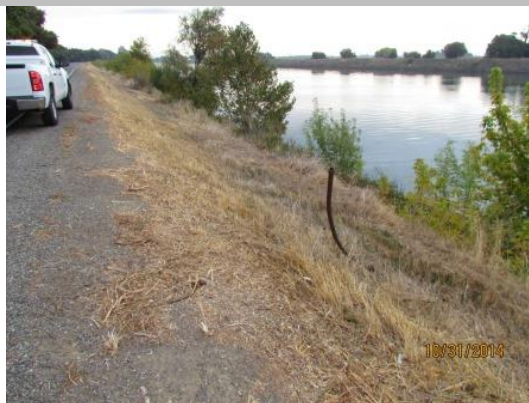
Photo 1 of 1 : SP_2019_RD0150_16_48_20190307_00025.jpg

LM Start	1.73	Rating **	M	Issue No.	48
LM End	1.73	Issue Type +	En	Location *	WS
Category	Earthen Levee			GPS Latitude/Longitude	
				Start	End
Item	Encroachments			38.345583 °	38.345583 °
				-121.554507 °	-121.554507 °
DWR ID	DWR_RD0150_02_f_2014_48				
Comment Code					
PO : Pole					
Inspector Comment					
A pole was found on the waterside slope of the levee. Most probably is connected to a pump.

A pole/pipe was found on the waterside slope of the levee looking upstream. Fall 2014

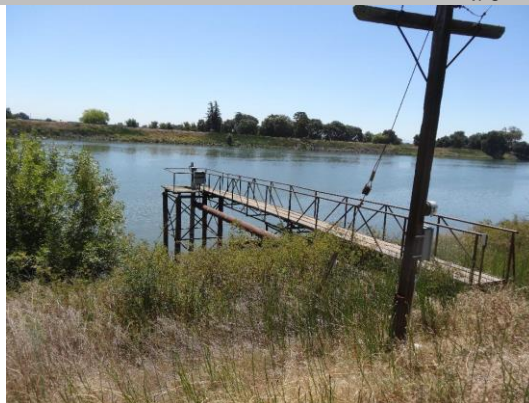
Photo 1 of 3 : UCIP_SP_2019_20348_34371.jpg

Comment Code					
Inspector Comment					
FS_ID:20348					
DS_ID:22395					
EP_NO: N/A					
Repair Type: Non-Urgent					
Crossing Status: Found					
UCIP Comments: - Operating during inspection.- Overhead powerline crossing- CMP riser with siphon breaker needs cleaning.					
FIELD_STRUCT_DESC: 12-inch steel irrigation discharge pipe through the levee, invert elevation 4 feet below the crown. Pump on a piling structure in the river. Power poles on both slopes. Ramp on the landside (LS) slope. Siphon breaker on the LS shoulder. [Additional Reference(s): DWR Levee Log, 2005. USACE Sacramento O&M Manual 112, March 1957, (RM 35.94)].					
FS Date: 8/27/2013

WS view: service pole, pipe & pump on piling structure in the stream.

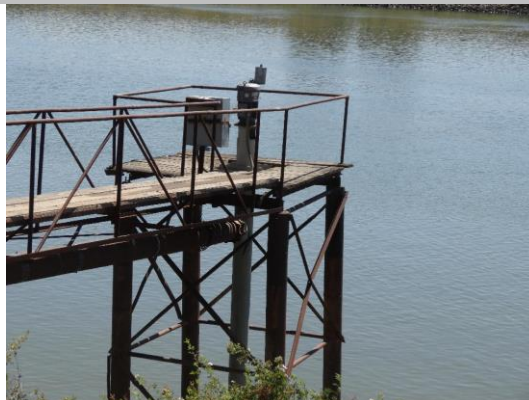
Photo 2 of 3 : UCIP_SP_2019_20348_34370.jpg

WS view: pipe & pump on piling structure in the stream.

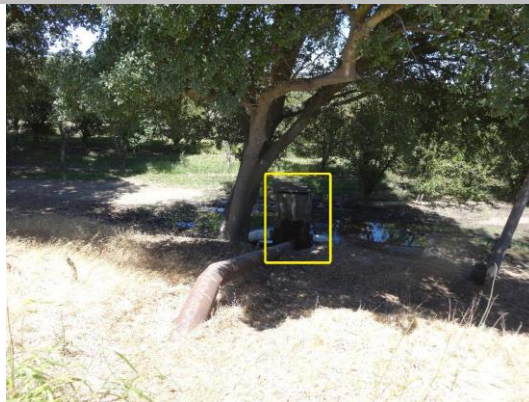
Photo 2 of 3 : UCIP_SP_2019_20731_34901.jpg

LM Start	2.14	Rating **	M	Issue No.	998	
LM End	2.14	Issue Type +	En	Location *		
Category	Supplemental			GPS Latitude/Longitude		
				Start		End
Item	DWR UCIP Field Study			38.347032 °		38.347032 °
				-121.547159 °		-121.547159 °
DWR ID	22396					
Comment Code						
Inspector Comment						
FS_ID:20731 DS_ID:22396 EP_NO: N/A Repair Type: Non-Urgent Crossing Status: Found UCIP Comments: - Operating during inspection. Leaky join at the concrete box.- Power overhead crossing. Power pole at waterside shoulder, and landside toe. FIELD_STRUCT_DESC: 12-inch steel irrigation discharge pipe through the levee, invert elevation 5 feet below the crown. Slant pump on the waterside (WS) slope. Power pole on the WS shoulder. [Additional Reference(s): DWR Levee Log, 2005. USACE Sacramento O&M Manual 112, March 1957, (RM 36.17)]. FS Date: 8/27/2013

LS view: concrete distribution box on levee toe and exposed steel pipe on levee slope.

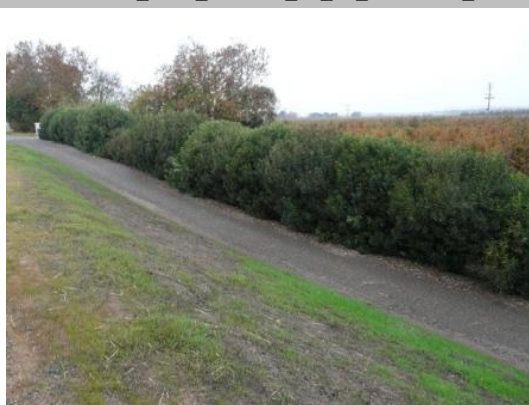
Photo 1 of 1 : SP_2019_RD0150_16_85_20190307_00055.jpg

LM Start	2.97	Rating **	U	Issue No.	85
LM End	3.01	Issue Type +	En	Location *	LS
Category	Earthen Levee			GPS Latitude/Longitude	
				Start	End
Item	Vegetation			38.352372 °	38.352802 °
				-121.534127 °	-121.533638 °
DWR ID	DWR_RD0150_02_s_2012_85				
Comment Code					
V6 : Landscaping					
Inspector Comment

Landscaping providing a screen for a residence on the landside of levee.

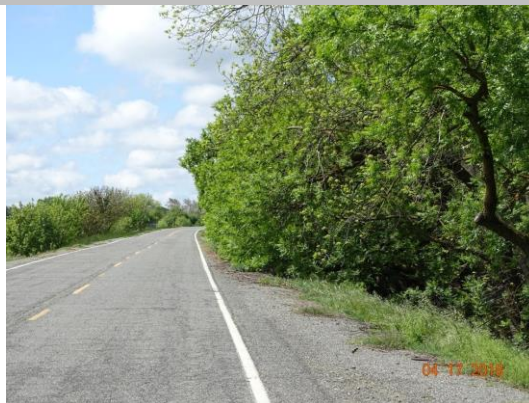
Photo 1 of 1 : SP_2019_RD0150_16_95_20190307_00060.jpg

LM Start	3.08	Rating **	U	Issue No.	95
LM End	3.10	Issue Type +	En	Location *	LS
Category	Earthen Levee			GPS Latitude/Longitude	
				Start	End
Item	Vegetation			38.353541 °	38.353822 °
				-121.532844 °	-121.532574 °
DWR ID	DWR_RD0150_02_s_2018_95				
Comment Code					
V6 : Landscaping					
Inspector Comment					
Trim trees on landside slope.

Vegetation landside looking southwest. Spring 2018

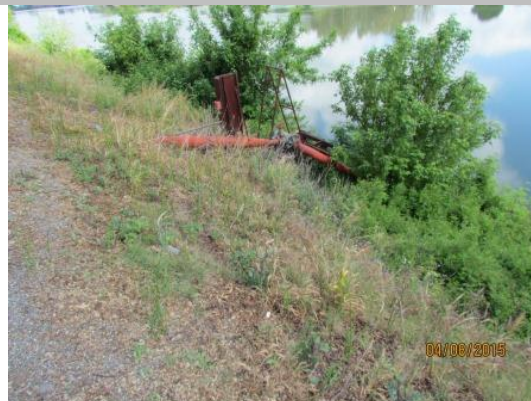
Photo 1 of 5 : SP_2019_RD0150_16_961_20190307_00066.jpg

LM Start	3.24	Rating **	M	Issue No.	961
LM End	3.24	Issue Type +	Ma	Location *	WS
Category	Earthen Levee			GPS Latitude/Longitude	
				Start	End
Item	Erosion / Bank Caving			38.355321 °	38.355321 °
				-121.530902 °	-121.530902 °
DWR ID	DWR_RD0150_02_s_2012_961				
Comment Code					
E2 : Schedule repair of erosion site prior to the next inspection.					
Inspector Comment					
Depressions into the waterward slope can be seen along the waterward slope at this site. Also note the damaged pump support, pump, and pipe just upstream of the site; they may contribute to the erosion in a high water event and should be removed.

View of the erosion on the waterside of the levee during spring 2015 inspection.

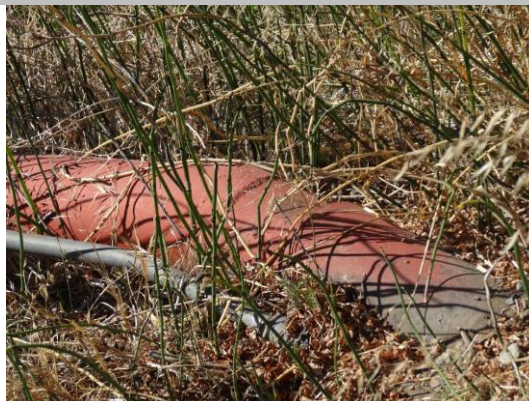
Photo 2 of 3 : UCIP_SP_2019_20736_34916.jpg

Comment Code						
Inspector Comment						
FS_ID:20736 DS_ID:22402 EP_NO: N/A Repair Type: Non-Urgent Crossing Status: Found UCIP Comments: - 10" steel pipe sleeved through 12" steel pipe.- main pipe bifurcates into two pipes on LS slope and connected to standpipe and concrete box.- 2" electric conduit on WS and power pole on LS.- needs filling into gap between 10" and 12" steel pipes on LS. FIELD_STRUCT_DESC: 12-inch steel irrigation discharge pipe through the levee, invert elevation 4 feet below the crown. Pump on a piling structure in the river. Concrete standpipe and concrete distribution box at the landside (LS) toe. (A. Green). [Additional Reference(s): DWR Levee Log, 2005. USACE Sacramento O&M Manual 112, March 1957, (RM 37.30)]. FS Date: 8/30/2013

WS view: steel pipe and GI conduit on levee slope.

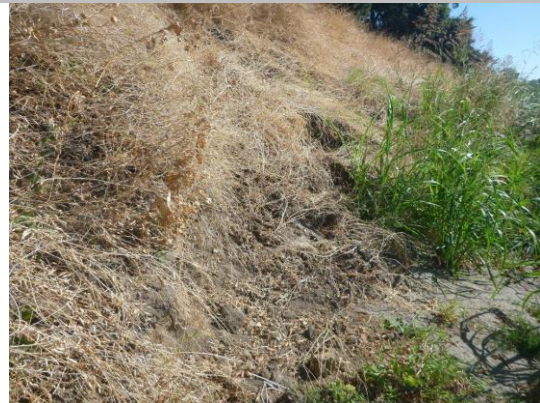
Photo 1 of 3 : LEVAL_SP_2019_287_2143.jpg

LM Start	3.42	Rating **	A/W	Issue No.	47
LM End	3.46	Issue Type +	Ma	Location *	WS
Category	Supplemental			GPS Latitude/Longitude	
				Start	End
Item	2017 Storm Damage			38.357183 °	38.357631 °
				-121.528547 °	-121.527981 °
DWR ID	DWR_RD0150_02_f_2017_47

Comment Code					
Inspector Comment					
Levee Evaluation Comments					
Description:The flood damage consists of a waterside erosion approximately 229 feet long on the west (right) bank of the Sacramento River. See attached pages for photos.					
Site ID No:287					
Site Designation:LMA-113					
Repair Type: Erosion					
Rating:Serious					
Field Date:7/17/2017					
Notes: Crown is a paved road. Erosion scarps upto 10 ft deep and within 5 ft of crown. Worse conditions on the DS end. Exposed filter fabric. Serious because of depth of erosion into levee, weak soil, and proximity to crown which is a high traffic public road. 2019 Spring DWR Inspection: Erosion was not visible. Slope appears to be intact to at least 5-10' from levee shoulder.

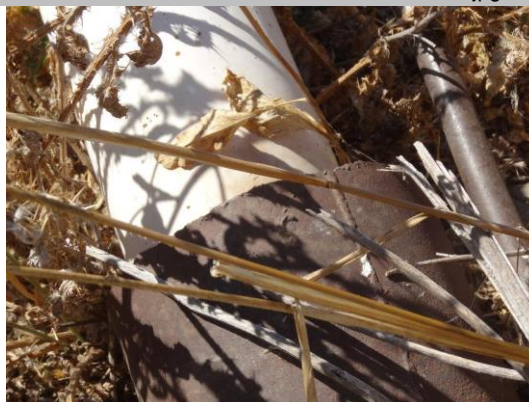
Photo 2 of 3 : UCIP_SP_2019_19846_33726.jpg

Comment Code						
Inspector Comment						
FS_ID:19846 DS_ID:22403 EP_NO: N/A Repair Type: Non-Urgent Crossing Status: Found UCIP Comments: - 8" pvc pipe sleeved into 12" steel pipe.- needs filling/grouting in gas between 8" pvc pipe and 12" steel pipe on WS.- 1.5" electric conduit on WS- 10" steel pipe extended to 8" pvc pipe on landside levee toe. FIELD_STRUCT_DESC: 12-inch steel irrigation discharge pipe through the levee, invert elevation 3 feet below the crown. Pump and gate valve on the waterside (WS) slope. (R. and J. Pylman). [Additional Reference(s): DWR Levee Log, 2005. USACE Sacramento O&M Manual 112, March 1957, (RM 37.56)]. FS Date: 8/30/2013

WS view: steel conduit (right); 8" pvc pipe sleeved into 12" steel pipe.

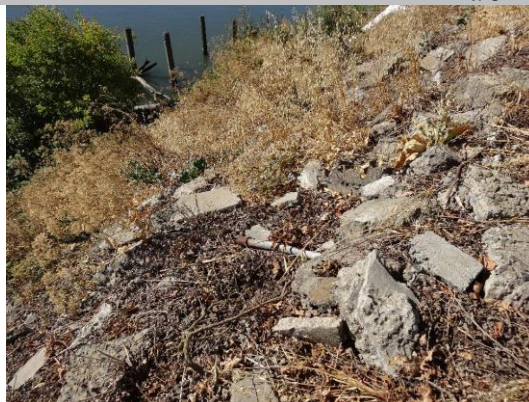
Photo 1 of 3 : UCIP_SP_2019_19848_33734.jpg

LM Start	3.51	Rating **	M	Issue No.	1001
LM End	3.51	Issue Type +	En	Location *	
Category	Supplemental			GPS Latitude/Longitude	
				Start	End
Item	DWR UCIP Field Study			38.358131 °	38.358131 °
				-121.527540 °	-121.527540 °
DWR ID	22404				
Comment Code					
Inspector Comment					
FS_ID:19848 DS_ID:22404 EP_NO: N/A Repair Type: Non-Urgent Crossing Status: Found UCIP Comments: - needs proper abandonment. FIELD_STRUCT_DESC: *ABANDONED* 4-inch steel pipe of an unknown purpose on the landside (LS) slope. 1-inch steel conduit on the waterside (WS) slope was found. FS Date: 8/30/2013

WS view: abandoned 1-inch conduit on levee slope.

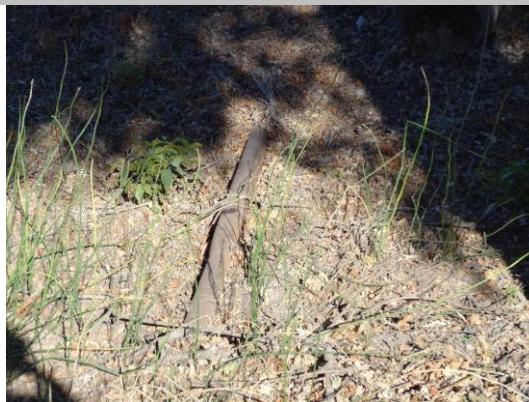
Photo 3 of 3 : UCIP_SP_2019_19848_33732.jpg

LM Start	3.51	Rating **	M	Issue No.	1001 (cont)	
LM End	3.51	Issue Type +	En	Location *		
Category	Supplemental			GPS Latitude/Longitude		
				Start	End	
Item	DWR UCIP Field Study			38.358131 °	38.358131 °	
				-121.527540 °	-121.527540 °	
DWR ID	22404					
Comment Code						
Inspector Comment						
FS_ID:19848 DS_ID:22404 EP_NO: N/A Repair Type: Non-Urgent Crossing Status: Found UCIP Comments: - needs proper abandonment. FIELD_STRUCT_DESC: *ABANDONED* 4-inch steel pipe of an unknown purpose on the landside (LS) slope. 1-inch steel conduit on the waterside (WS) slope was found. FS Date: 8/30/2013

LS view: abandoned 4-inch steel pipe on levee slope.

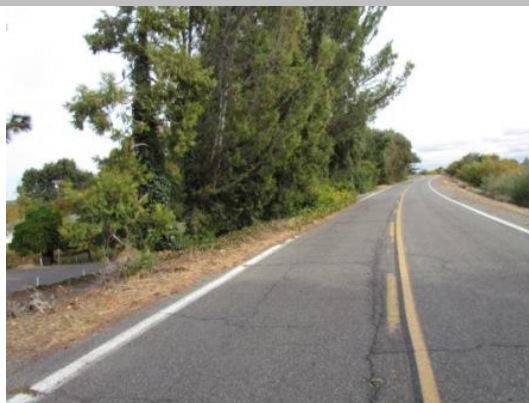
Photo 1 of 1 : SP_2019_RD0150_16_82_20190307_00054.jpg

LM Start	3.54	Rating **	U	Issue No.	82
LM End	3.67	Issue Type +	En	Location *	LS
Category	Earthen Levee			GPS Latitude/Longitude	
				Start	End
Item	Vegetation			38.358530 °	38.359749 °
				-121.527162 °	-121.525245 °
DWR ID	DWR_RD0150_02_s_2012_82				
Comment Code					
V6 : Landscaping					
Inspector Comment

Landscaping was blocking the visibility on the landside of the levee looking upstream.

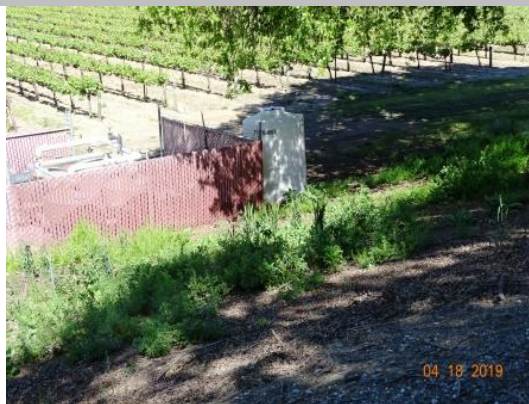
Photo 1 of 1 : SP_2019_RD0150_16_83_20190422_00129.jpg

LM Start	3.90	Rating **	M	Issue No.	83
LM End	3.90	Issue Type +	En	Location *	LS
Category	Earthen Levee			GPS Latitude/Longitude	
				Start	End
Item	Encroachments			38.362193 °	38.362193 °
				-121.522682 °	-121.522682 °
DWR ID	DWR_RD0150_02_s_2019_83				
Comment Code					
TA : Tank					
Inspector Comment					
Tank at toe does not have a permit.

View of tank encroachment at levee toe. Spring 2019

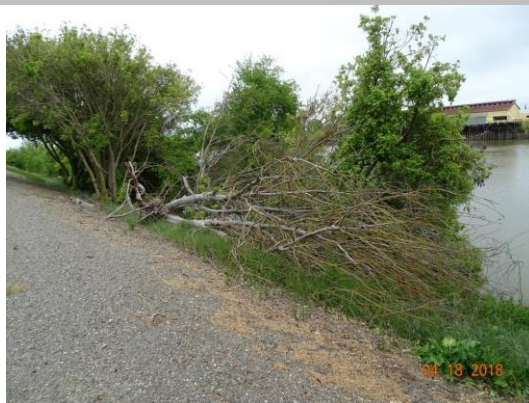
Photo 1 of 1 : SP_2019_RD0150_16_107_20190307_00063.jpg

LM Start	4.27	Rating **	M	Issue No.	107
LM End	4.27	Issue Type +	Ma	Location *	WS
Category	Earthen Levee			GPS Latitude/Longitude	
				Start	End
Item	Encroachments			38.367507 °	38.367507 °
				-121.522493 °	-121.522493 °
DWR ID	DWR_RD0150_02_s_2018_107				
Comment Code					
TR : Tree or limb					
Inspector Comment					
Remove fallen tree on waterside slope.

View of fallen tree on waterside looking northeast. Spring 2018

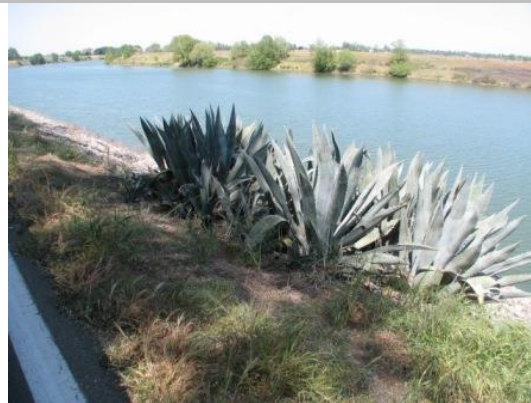
Photo 1 of 1 : SP_2019_RD0150_16_28_20190307_00012.jpg

LM Start	4.69	Rating **	M	Issue No.	28
LM End	4.69	Issue Type +	Ma	Location *	WS
Category	Earthen Levee			GPS Latitude/Longitude	
				Start	End
Item	Vegetation			38.373485 °	38.373485 °
				-121.523963 °	-121.523963 °
DWR ID	DWR_RD0150_02_s _ 2012_28				
Comment Code					
V2 : Remove the wild growth other than native grasses from the levee slopes.					
Inspector Comment

View of century plant on waterward slope.

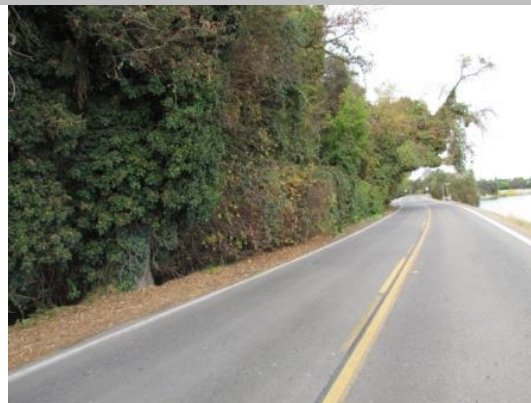
Photo 1 of 1 : SP_2019_RD0150_16_76_20190307_00051.jpg

LM Start	4.70	Rating **	U	Issue No.	76
LM End	4.72	Issue Type +	En	Location *	LS
Category	Earthen Levee			GPS Latitude/Longitude	
				Start	End
Item	Vegetation			38.373688 °	38.373970 °
				-121.524280 °	-121.524403 °
DWR ID	DWR_RD0150_02_s _ 2012_76				
Comment Code					
V6 : Landscaping					
Inspector Comment

Trees are obstructing the view of the landside slope of the levee looking upstream.

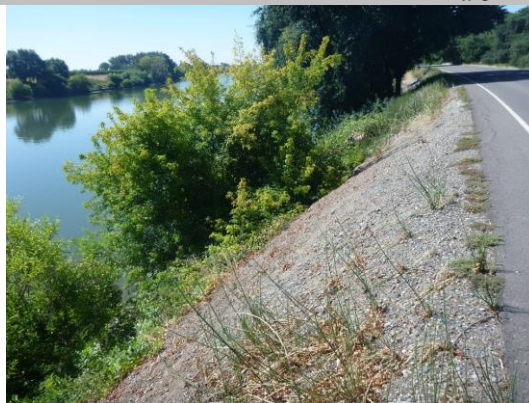
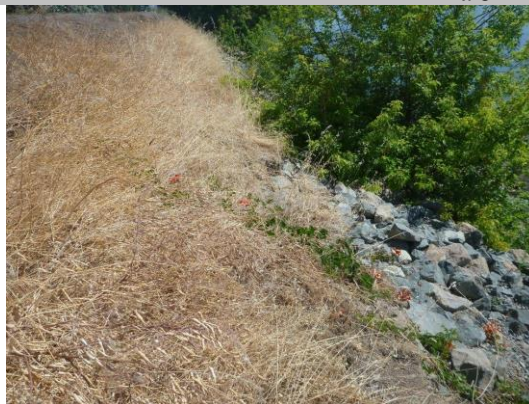
Description: The flood damage consists of a waterside erosion approximately 447 feet long on the west (right) bank of the Sacramento River. See attached pages for photos.

LM Start	5.04	Rating **	A/W	Issue No.	50 (cont)
LM End	5.12	Issue Type +	Ma	Location *	WS

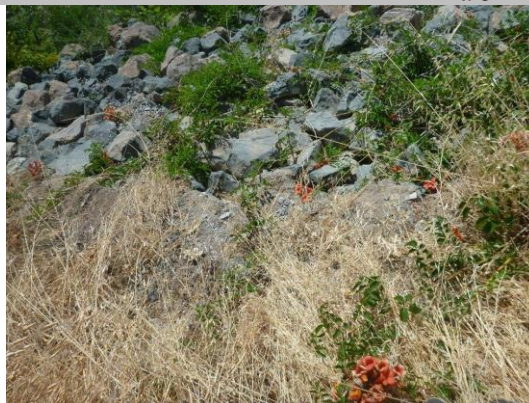
Photo 4 of 4 : LEVAL_SP_2019_288_2157.jpg

Comment Code					
Inspector Comment					
<p>Levee Evaluation Comments</p> <p>Description: The flood damage consists of a waterside erosion approximately 447 feet long on the west (right) bank of the Sacramento River. See attached pages for photos.</p> <p>Site ID No: 288</p> <p>Site Designation: LMA-114</p> <p>Repair Type: Erosion</p> <p>Rating: Area of Concern</p> <p>Field Date: 7/17/2017</p> <p>Notes: Crown is a paved road. Much of site was not accessible because of thorny veg. Scarps were only about 1 ft deep where it was accessible so rated it a lower priority. Irrigation pipe within the site. A boat view would be helpful here. Fall 2018 DWR Inspector: Erosion along bank not visible from levee crown. Spring 2019 DWR Inspector: Slope appears to remain intact for at least 10' that is visible from the levee shoulder (portion without vegetation).</p>

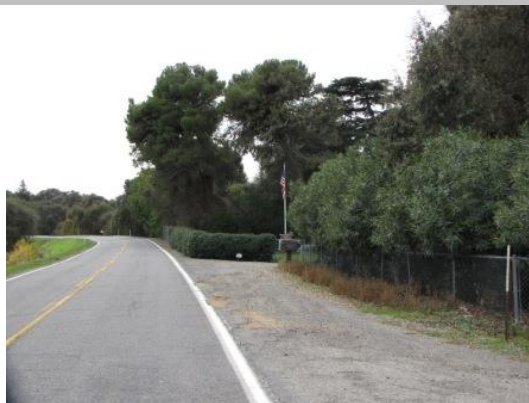
Photo 1 of 1 : SP_2019_RD0150_16_75_20190307_00050.jpg

LM Start	5.10	Rating **	U	Issue No.	75
LM End	5.14	Issue Type +	En	Location *	LS
Category	Earthen Levee			GPS Latitude/Longitude	
				Start	End
Item	Vegetation			38.379198 °	38.379839 °
				-121.525263 °	-121.524968 °
DWR ID	DWR_RD0150_02_s_2012_75				
Comment Code					
V6 : Landscaping					
Inspector Comment					
Trees have been trimmed and thinned, but bushes remain at levee shoulder.

View of landscaping along the landward shoulder and slope looking downstream.

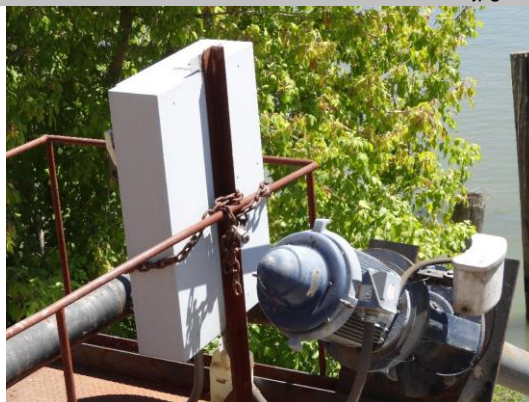
Photo 2 of 3 : UCIP_SP_2019_20740_34940.jpg

WS view: pipe, slant pump & pump platform on stream bank.

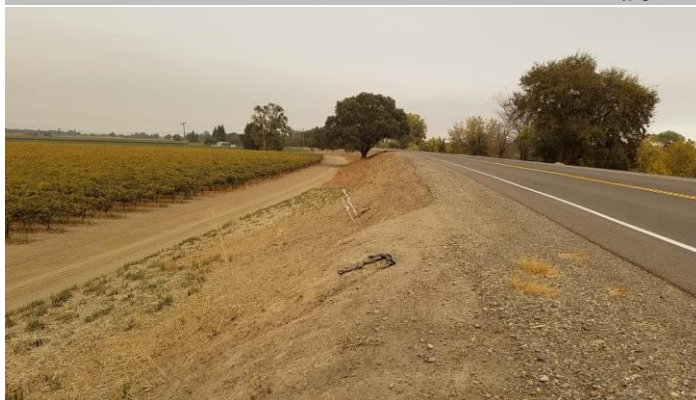
Photo 1 of 2 : SP_2019_RD0150_16_52_20190307_00031.jpg

LM Start	5.90	Rating **	M	Issue No.	52
LM End	5.90	Issue Type +	Ma	Location *	LS
Category	Earthen Levee			GPS Latitude/Longitude	
				Start	End
Item	Erosion / Bank Caving			38.387915 °	38.387915 °
				-121.516002 °	-121.516002 °
DWR ID	DWR_RD0150_02_f_2016_52				
Comment Code					
E2 : Schedule repair of erosion site prior to the next inspection.					
Inspector Comment					
Repair erosion due to runoff.

View of erosion due to runoff. Fall 2018

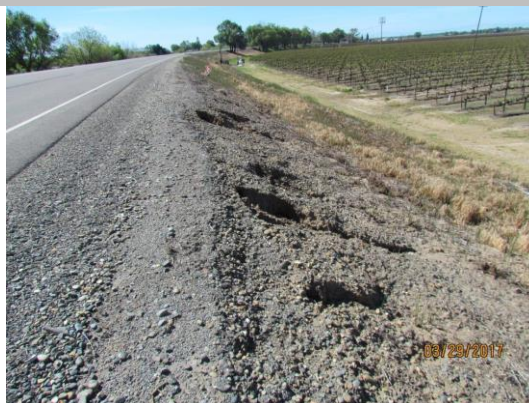
Photo 2 of 2 : SP_2019_RD0150_16_52_20190307_00032.jpg

View of the erosion on the landside of the levee during spring 2017 inspection.

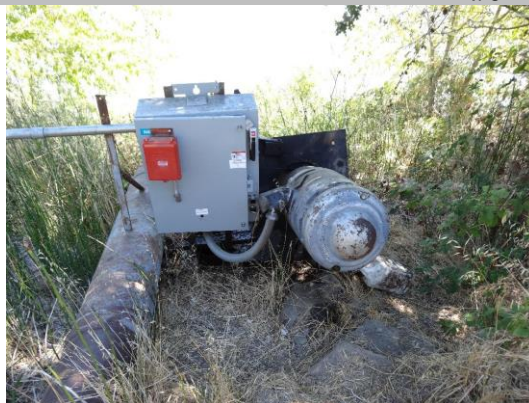
Photo 1 of 3 : UCIP_SP_2019_20748_34967.jpg

Comment Code					
Inspector Comment					
FS_ID:20748					
DS_ID:22412					
EP_NO: N/A					
Repair Type: Non-Urgent					
Crossing Status: Found					
UCIP Comments: - slope erosion due leaky siphon breaker at CMP riser- leaky pipe and pump- service pole on LS- 2" electric conduit on WS					
FIELD_STRUCT_DESC: 10-inch steel irrigation discharge pipe and an electrical conduit through the levee, invert elevation 4.8 feet below the crown. Slant pump on the waterside (WS) slope. Siphon breaker in a corrugated metal pipe (CMP) riser on the landside (LS) shoulder. Slope erosion on the LS at the siphon breaker. (Ed Boyles). [Additional Reference(s): DWR Levee Log, 2005. USACE Sacramento O&M Manual 112, March 1957, (RM 40.22)].					
FS Date: 8/30/2013

WS view: steel pipe and slant pump on levee slope.

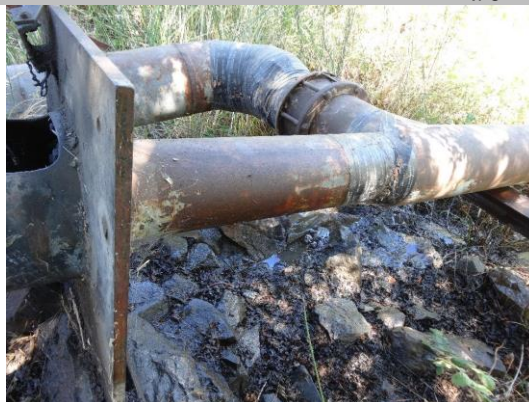
Photo 2 of 3 : UCIP_SP_2019_20748_34966.jpg

WS view: leaky steel pipe and slant pump on levee slope.

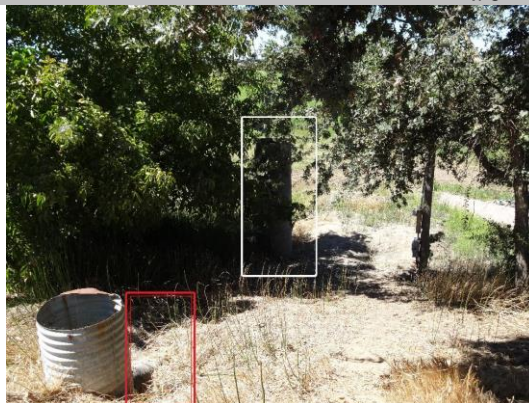
Photo 3 of 3 : UCIP_SP_2019_20748_34965.jpg

Comment Code						
Inspector Comment						
FS_ID:20748						
DS_ID:22412						
EP_NO: N/A						
Repair Type: Non-Urgent						
Crossing Status: Found						
UCIP Comments: - slope erosion due leaky siphon breaker at CMP riser- leaky pipe and pump- service pole on LS- 2" electric conduit on WS						
FIELD_STRUCT_DESC: 10-inch steel irrigation discharge pipe and an electrical conduit through the levee, invert elevation 4.8 feet below the crown. Slant pump on the waterside (WS) slope. Siphon breaker in a corrugated metal pipe (CMP) riser on the landside (LS) shoulder. Slope erosion on the LS at the siphon breaker. (Ed Boyles). [Additional Reference(s): DWR Levee Log, 2005. USACE Sacramento O&M Manual 112, March 1957, (RM 40.22)].						
FS Date: 8/30/2013

LS view: siphon breaker in CMP riser (left) on levee slope and concrete standpipe at levee toe (right).

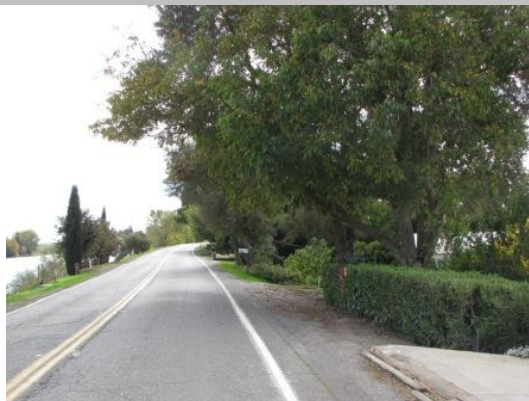
Photo 1 of 1 : SP_2019_RD0150_16_65_20190307_00046.jpg

LM Start	6.39	Rating **	U	Issue No.	65
LM End	6.46	Issue Type +	En	Location *	LS
Category	Earthen Levee			GPS Latitude/Longitude	
				Start	End
Item	Vegetation			38.394935 °	38.395931 °
				-121.514597 °	-121.514604 °
DWR ID	DWR_RD0150_02_s _ 2012_65				
Comment Code					
V6 : Landscaping					
Inspector Comment

View of landscaping along the landside shoulder and slope looking downstream.

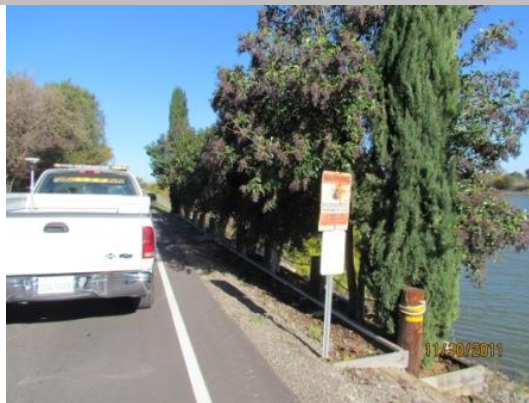
Photo 1 of 1 : SP_2019_RD0150_16_34_20190307_00015.jpg

LM Start	6.42	Rating **	M	Issue No.	34
LM End	6.42	Issue Type +	En	Location *	WS
Category	Earthen Levee			GPS Latitude/Longitude	
				Start	End
Item	Vegetation			38.395340 °	38.395340 °
				-121.514528 °	-121.514528 °
DWR ID	DWR_RD0150_02_s_2012_34				
Comment Code					
V6 : Landscaping					
Inspector Comment

Landscaping was found on the waterside of the levee looking upstream.
Fall 2011

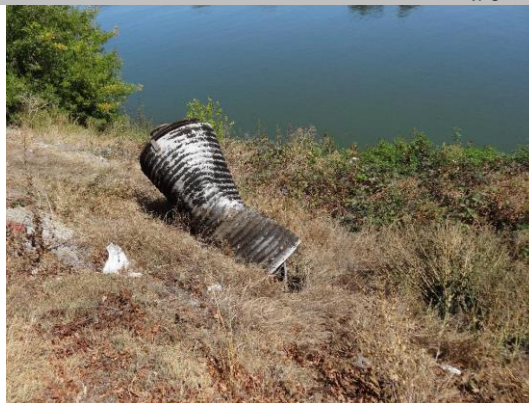
Photo 1 of 3 : UCIP_SP_2019_50669_34985.jpg

FS_ID:50669
DS_ID:22413
EP_NO: N/A
Repair Type: Non-Urgent
Crossing Status: Found
UCIP Comments: 11/09/2016 Per FPIIB Inspector Pavel Kazi, the CMP riser has been removed and the pipe is now exposed. Pipe still requires proper abandonment. (K. Fazel - UCIP)08/30/2013 Only an abandoned and dismantled CMP riser with gate valve found on WS levee slope. May need proper abandonment. (P. Amatya - DWR)
FIELD_STRUCT_DESC: *ABANDONED* 6-inch steel irrigation discharge pipe, 10 feet below the crown. Gate valve on each end, though only one was found on the waterside (WS) in 2013. Pump on the landside (LS), 10 feet from the LS toe, not found in 2013. Riser on the WS slope has been removed as of the 2016 inspection. (C. Godfrey). [Additional Reference(s): DWR Levee Log, 2005. USACE Sacramento O&M Manual 112, March 1957, (RM 40.60), referenced as invert elevation 8.5 feet below the crown].
FS Date: 11/9/2016

WS view: an abandoned and dismantled CMP riser on WS levee slope.

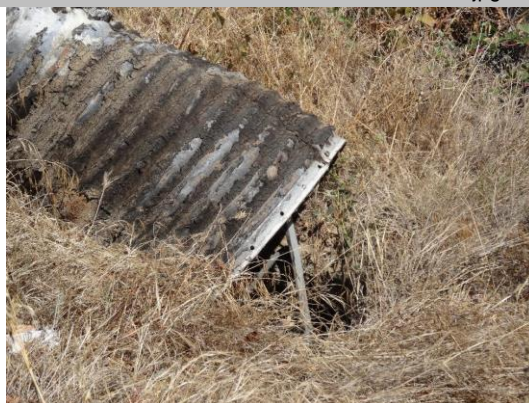
Photo 2 of 3 : UCIP_SP_2019_50669_34984.jpg

WS view: closer view of an abandoned and dismantled CMP riser on WS levee slope.

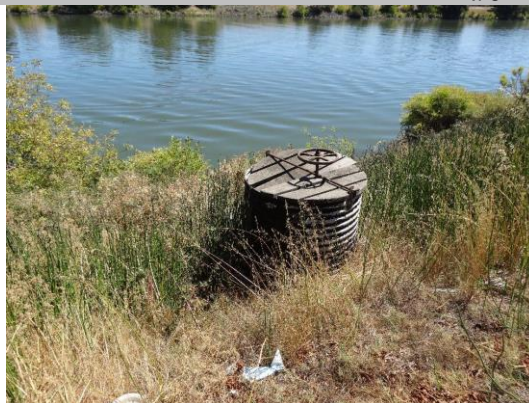
Photo 1 of 2 : UCIP_SP_2019_41720_34081.jpg

LM Start	6.57	Rating **	M	Issue No.	1006
LM End	6.57	Issue Type +	En	Location *	
Category	Supplemental			GPS Latitude/Longitude	
				Start	End
Item	DWR UCIP Field Study			38.397451 °	38.397451 °
				-121.514601 °	-121.514601 °
DWR ID	22425				
Comment Code					
Inspector Comment					
FS_ID:41720 DS_ID:22425 EP_NO: N/A Repair Type: Non-Urgent Crossing Status: Found UCIP Comments: Need to clear dense vegetation on WS.- water filtration plant on LS levee toe.- Slide gate on CMP riser on WS. FIELD_STRUCT_DESC: 8-inch irrigation discharge pipe of an unknown material through the levee, 12 feet below the crown. Gate valve in a corrugated metal pipe (CMP) riser on the waterside (WS) slope. Pump at the landside (LS) toe. (Joe Gomez). [Additional Reference(s): DWR Levee Log, 2005]. FS Date: 8/30/2013

WS view: CMP riser with gate valve on levee slope. Dense vegetation on levee slope and stream bank.

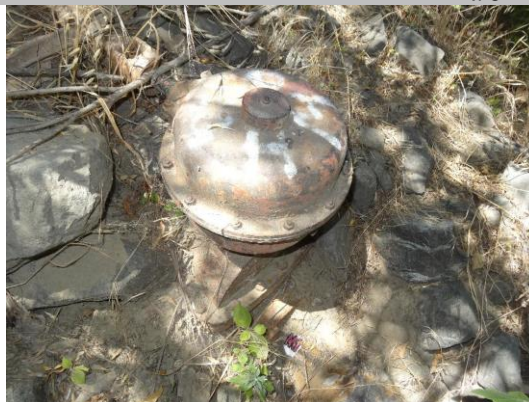
Photo 2 of 3 : UCIP_SP_2019_41646_34101.jpg

WS view: An abandoned old gate valve on inlet steel pipe on stream bank.

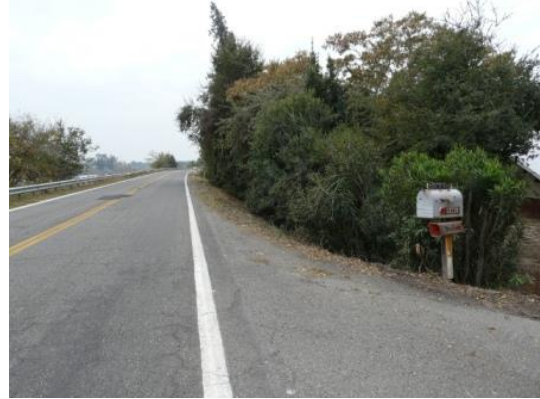
Photo 1 of 1 : SP_2019_RD0150_16_60_20190307_00043.jpg

LM Start	6.78	Rating **	U	Issue No.	60
LM End	6.87	Issue Type +	En	Location *	LS
Category	Earthen Levee			GPS Latitude/Longitude	
				Start	End
Item	Vegetation			38.400528 °	38.401707 °
				-121.515102 °	-121.515453 °
DWR ID	DWR_RD0150_02_s_2012_60				
Comment Code					
V6 : Landscaping					
Inspector Comment					
A portion of bushes have been cleared from levee easement.

View of dense landscaping providing a screen for a residence on the landside of levee.

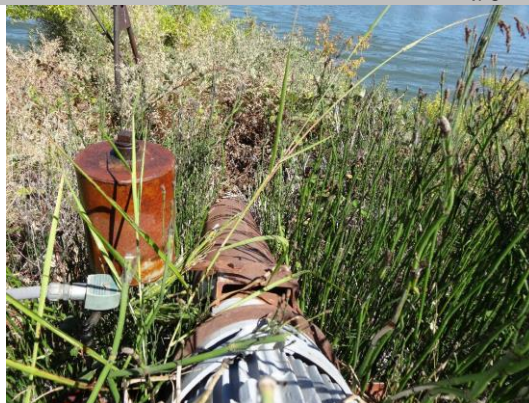
Photo 2 of 3 : UCIP_SP_2019_53333_34161.jpg

WS view: steel intake pipe and pump on levee slope. Dense vegetation on levee slope.

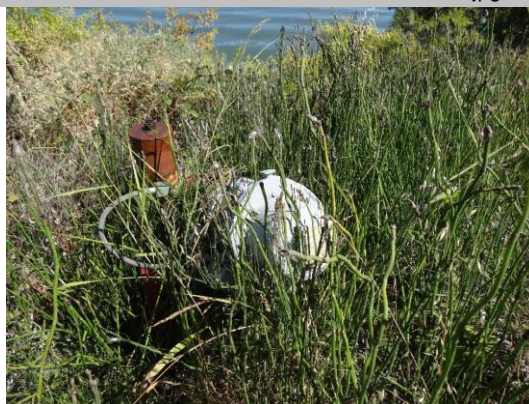
Photo 3 of 3 : UCIP_SP_2019_53333_34160.jpg

WS view: pump on levee slope. Dense vegetation on levee slope.

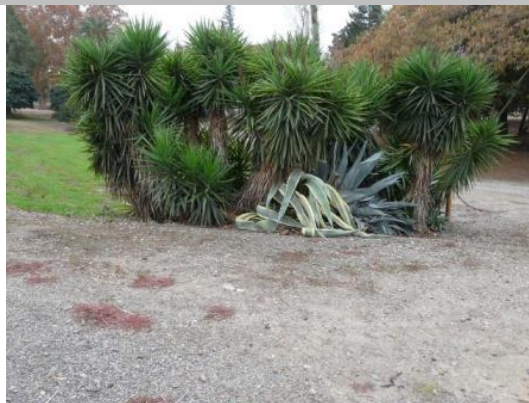
Photo 1 of 1 : SP_2019_RD0150_16_56_20190307_00039.jpg

LM Start	7.79	Rating **	M	Issue No.	56
LM End	7.79	Issue Type +	En	Location *	LS
Category	Earthen Levee			GPS Latitude/Longitude	
				Start	End
Item	Vegetation			38.413705 °	38.413705 °
				-121.522806 °	-121.522806 °
DWR ID	DWR_RD0150_02_s_2012_56				
Comment Code					
V6 : Landscaping					
Inspector Comment

Landscaping on landside of levee

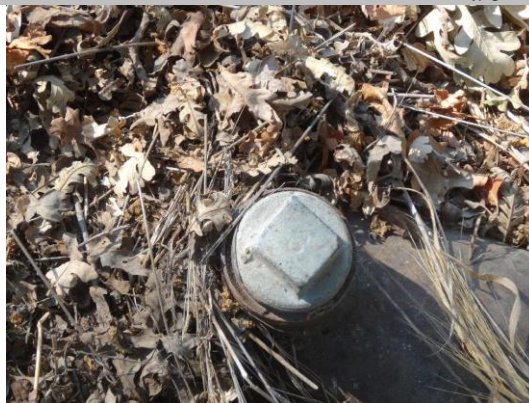
Photo 2 of 3 : UCIP_SP_2019_42694_32004.jpg

LM Start	0.39	Rating **	M	Issue No.	951 (cont)	
LM End	0.39	Issue Type +	En	Location *		
Category	Supplemental			GPS Latitude/Longitude		
				Start	End	
Item	DWR UCIP Field Study			38.337928 °	38.337928 °	
				-121.581496 °	-121.581496 °	
DWR ID	22453					
Comment Code						
Inspector Comment						
FS_ID:42694 DS_ID:22453 EP_NO: 13612 Repair Type: Non-Urgent Crossing Status: Found UCIP Comments: Abandoned. Proper abandone needs. FIELD_STRUCT_DESC: *ABANDONED* 6-inch steel gravity irrigation pipe through the levee, 3.5 feet below the crown. Pump and gate valve on the waterside (WS) slope. (Runyon). [Additional Reference(s): DWR Levee Log, 2005]. FS Date: 8/20/2013

WS view: safety valve on steel pipe.

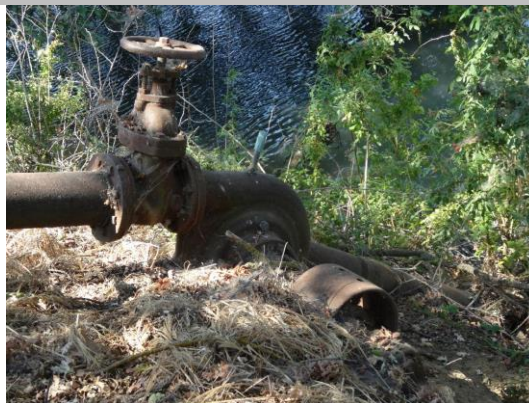
Photo 3 of 3 : UCIP_SP_2019_42694_32003.jpg

WS view: abandoned pipe, gate valve, and pump on levee slope.

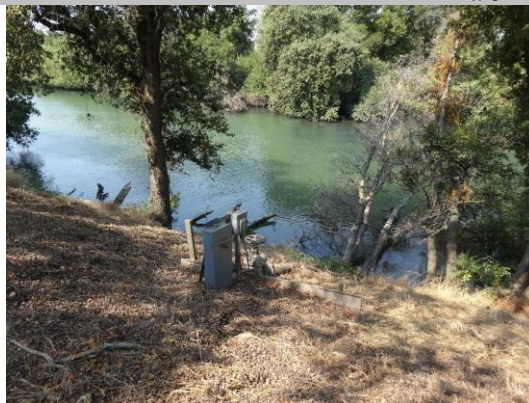
Photo 3 of 3 : UCIP_SP_2019_42693_31977.jpg

WS view: pipe and pump on levee slope.

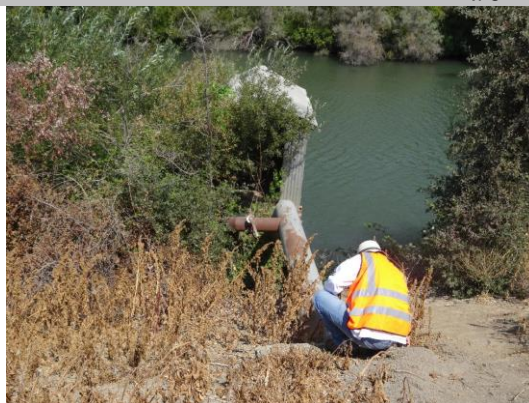
Photo 1 of 3 : UCIP_SP_2019_19112_32044.jpg

LM Start	1.35	Rating **	M	Issue No.	953
LM End	1.35	Issue Type +	En	Location *	
Category	Supplemental			GPS Latitude/Longitude	
				Start	End
Item	DWR UCIP Field Study			38.347489 °	38.347489 °
				-121.573302 °	-121.573302 °
DWR ID	22433				
Comment Code					
Inspector Comment					
FS_ID:19112 DS_ID:22433 EP_NO: N/A Repair Type: Non-Urgent Crossing Status: Found UCIP Comments: No handrail on wooden walkway. FIELD_STRUCT_DESC: 14-inch steel irrigation discharge pipe through the levee, invert elevation 8 feet below the crown. Pump in a pump house on the waterside (WS) slope. Service pole and steel distribution box on the landside (LS) slope. (A. Pylman). [Additional Reference(s): DWR Levee Log, 2005. USACE Sacramento O&M Manual 112, March 1957, (HLM 1.39)]. FS Date: 8/20/2013

WS view: pipe on levee slope and pump house in channel.

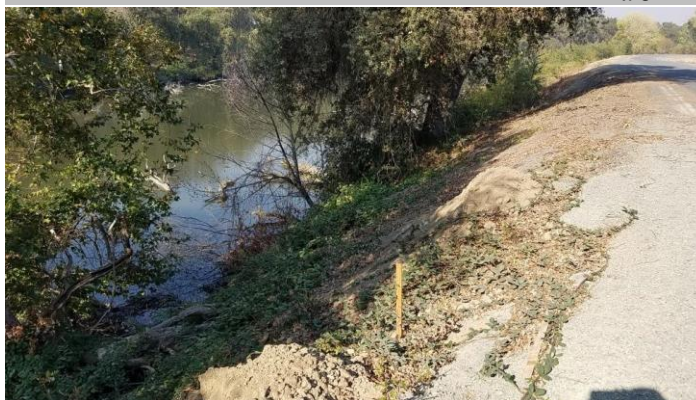
Photo 1 of 2 : SP_2019_RD0150_17_35_20190307_00015.jpg

View of erosion at top of slope. Fall 2018

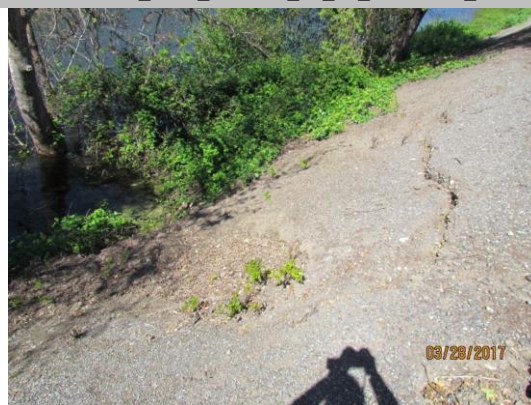
Photo 2 of 2 : SP_2019_RD0150_17_35_20190307_00016.jpg

View of erosion on the waterside of the levee during spring 2017 inspection.

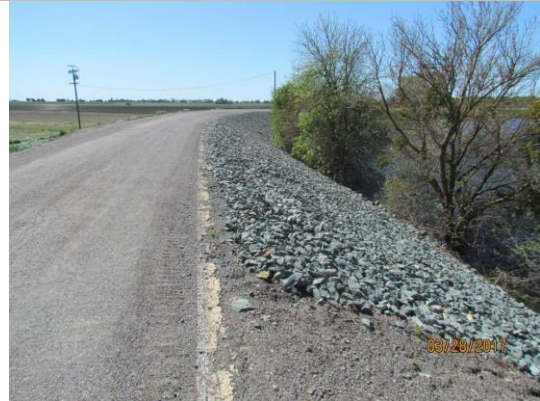
Photo 1 of 1 : SP_2019_RD0150_17_76_20190307_00064.jpg

LM Start	3.37	Rating **	A/W	Issue No.	76
LM End	3.45	Issue Type +	Ma	Location *	WS
Category	Earthen Levee			GPS Latitude/Longitude	
				Start	End
Item	Riprap Revetments			38.363380 °	38.364325 °
				-121.555715 °	-121.555330 °
DWR ID	DWR_RD0150_03_s_2017_76				
Comment Code					
Inspector Comment					
Riprap remains intact.

View of the new riprap on the waterside slope of the levee looking downstream. Spring 2017

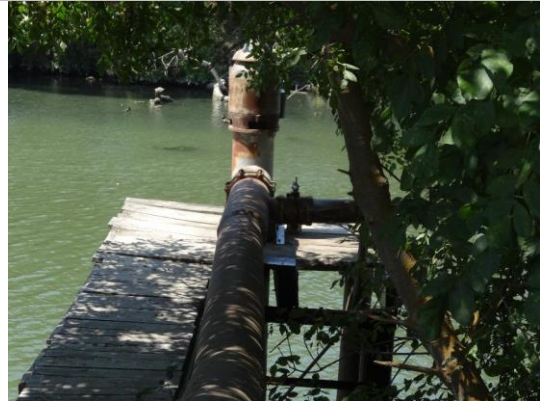
Photo 2 of 3 : UCIP_SP_2019_53334_35012.jpg

FS_ID:53334
DS_ID:22439
EP_NO: N/A
Repair Type: Urgent
Crossing Status: Found
UCIP Comments: 06/05/2018 Same as last inspection; LS erosion looks the same if not slightly worse, so the crossing remains Urgent (DWR UCIP - D. Sanoski)03/30/2017 Riprap laid around pipe on WS slope. Source of erosion has not been addressed, nor has LS toe been repaired. Update and photo courtesy of Pavel Kazi, FPIIB Inspector, as a part of his Sprint 2017 Inspections. (K. Fazel - UCIP) 11/10/2016 Erosion at LS toe has progressed since last inspection and is now severe. Photo courtesy of Pavel Kazi, FPIIB Inspector, as a part of his Fall 2016 Inspections. Crossing has been upgraded from Non-Urgent to Urgent. (K. Fazel - UCIP)08/20/2013 Leaky concrete standpipe on landside levee toe creating some erosion.- pump was working at the time of inspection. (P. Amatya - DWR)
FIELD_STRUCT_DESC: 8-inch steel irrigation discharge pipe through the levee, invert elevation 3.7 feet below the crown. Service pole on the waterside (WS) slope. Pump on a piling structure in the stream. Concrete standpipe at the landside (LS) toe. [Additional Reference(s): DWR Levee Log, 2005. USACE Sacramento O&M Manual 112, March 1957, (RM 3.45)].

WS view: steel pipe & pump, walkway, pump support in the channel.

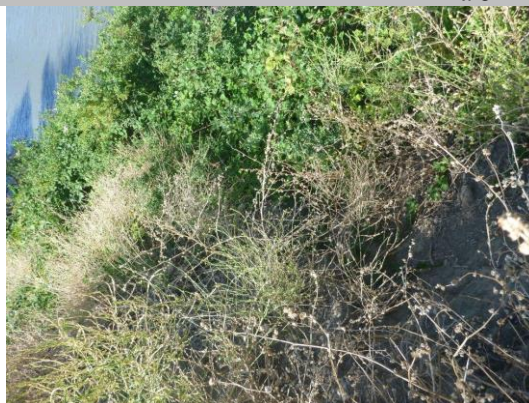
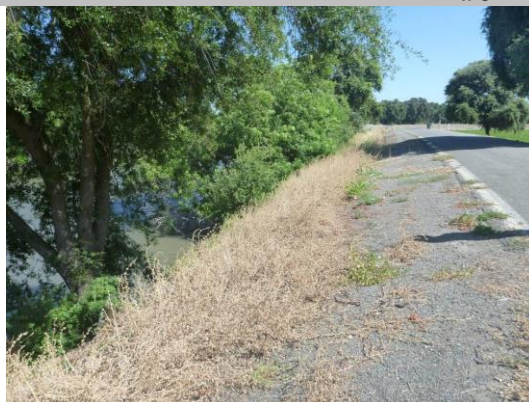
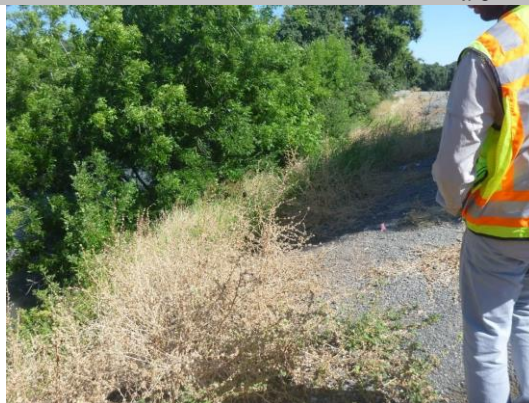
Comment Code					
Inspector Comment					
Levee Evaluation Comments					
Description:On 11 January 2017 and 7 February 2017, waterside instability and erosion were observed on the east (left) bank of Elk Slough. The site is approximately 43 feet long and 11 feet down from the levee crest. See attached pages for photos.					
Site ID No:302					
Site Designation:LMA-128					
Repair Type: Erosion					
Rating:Area of Concern					
Field Date:7/18/2017					
Notes: Erosion on lower 2/3 of slope. Crown is a paved road. Area of concern because erosion was not as severe and there was lots of vegetation on the lower slope indicating damage may be older. WS slope has been rocked just downstream of this site. 2019 Spring DWR Inspection: No new erosion was observed during the inspection.

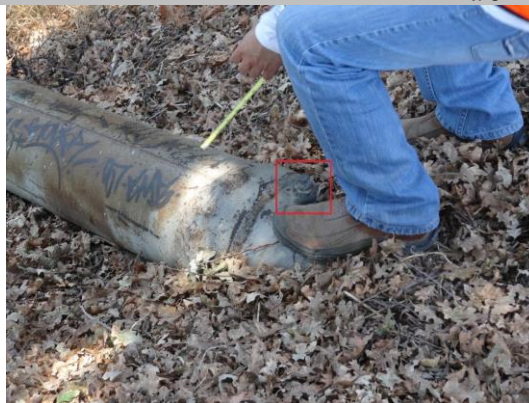
Photo 2 of 3 : UCIP_SP_2019_50202_35021.jpg

Comment Code						
Inspector Comment						
FS_ID:50202 DS_ID:22440 EP_NO: N/A Repair Type: Non-Urgent Crossing Status: Found UCIP Comments: 07/07/2016: Unable to locate evidence of major depression of WS slope. Only slight depression on WS slope above pump. Though this is an up-and-over pipe, no positive closure device found. Inlet in LS standpipe is capped with a board. If no longer in use, needs to be abandoned properly. Siphon breaker/vent on WS needs a cover. Wave-wash run-up along river bank characteristic of much of Elk Slough. Crossing has been downgraded from Urgent to Non-Urgent. (K. Fazel - UCIP)08/20/2013:Levee damage.Gate valve on WS not found. (P. Amatya - DWR) FIELD_STRUCT_DESC: 12-inch steel irrigation discharge pipe through the levee, invert elevation 5.9 feet below the crown. Slant pump on the waterside (WS) slope. Vent/siphon breaker at the apex of the pipe on the WS. Concrete platform lies next to the pump on the WS. Concrete standpipe and service pole with meter at the landside (LS) toe. Property owner is Ken Pylman at (916) 775-1066. [Additional Reference(s): DWR Levee Log, 2005. USACE Sacramento O&M Manual 112, March 1957, (HLM 3.73)]. FS Date: 7/7/2016

WS view: steel pipe with safety valve (marked) on levee slope.
